Manhole Inspection Summary

Manhole # S05AA2033MH

Insp Date: **10/13/06 11:12 AM**

Location Address: **5934 CROSS COUNTRY BLVD** Cross Street: **SIMMONDS AVE**

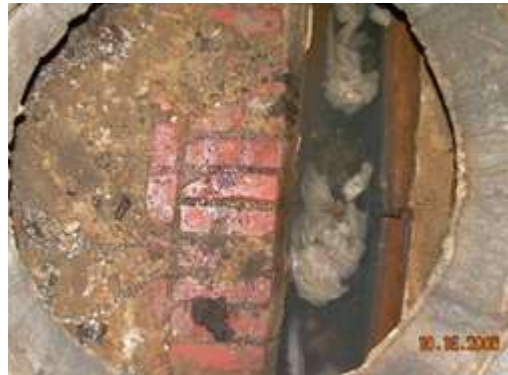
Top View

Evidence of surcharge - Bench debris.
Channel debris.

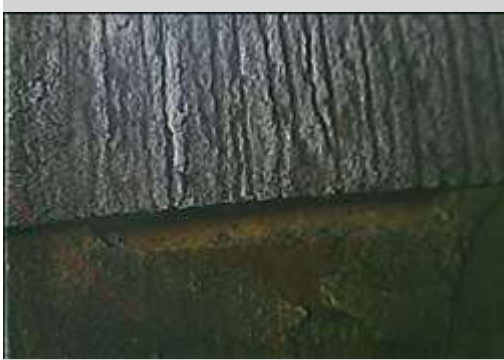
Defect

Adjustment infiltration.

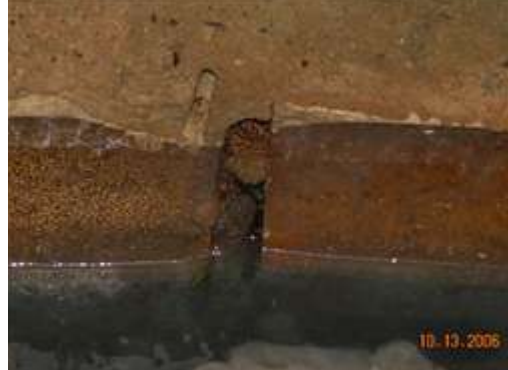
Defect

Channel deterioration (joint).

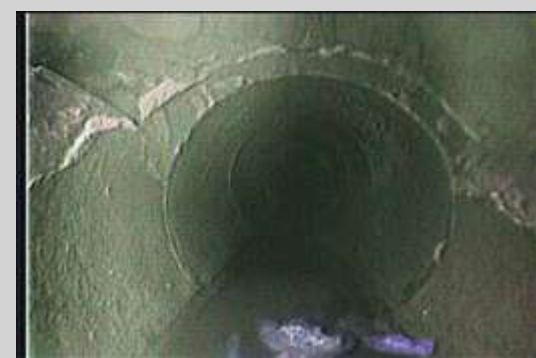
12 in. Circular Gravity Sewer Pipe Out @ 12 O'Clock

Deposits: ☐ None ☒ **Mud** ☐ Sludge ☒ **Debris** ☐ Grease

Infiltration: **Evidence** Pipe Seal Cond: **Cracked**

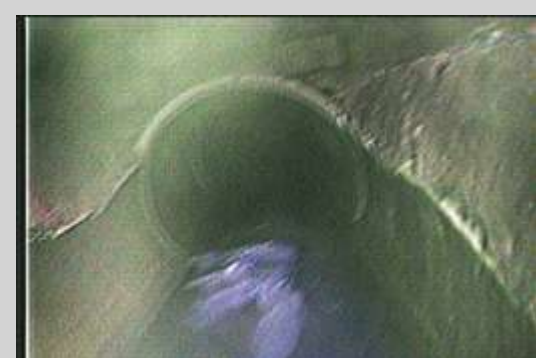
12 in. Circular Gravity Sewer Pipe In @ 6 O'Clock

Barrel deterioration and infiltration.

Infiltration: **Evidence** Pipe Seal Cond: **Cracked**
